Research Report No. 10

The 1995 Predisturbance Wreck Site Investigation at Claflin Point, Little Sturgeon Bay, Wisconsin

Bradley A. Rodgers

Program in Maritime History and
Nautical Archaeology
East Carolina University
Greenville, North Carolina

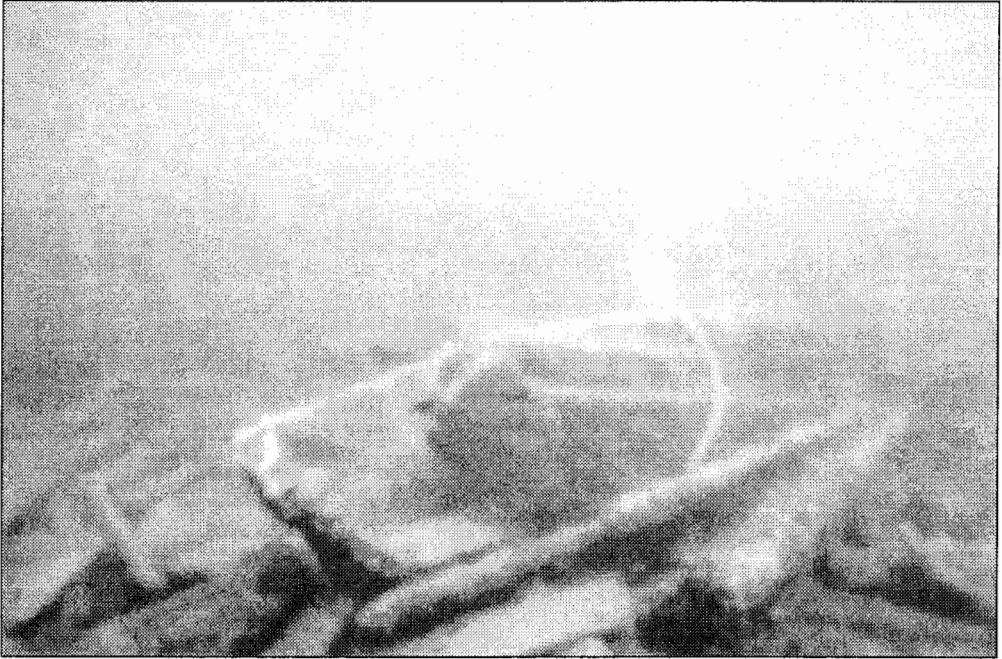
Plate 1. The bow section looking aft along the baseline. Note the iron keel shoe and the rabbet notched into the keel to admit the garboard strake. The stem of the ship would have attached in this area.

Actual fieldwork at Claflin Point began with the relocation of the main wreck section on 12 September 1995. Following this, a baseline was established at the bow (Plate 1) and positioned over the centerline of the main wreck segment, angling off to nearby wreckage. The scaled baseline gave archaeologists a reference while at the same time acting as a tool to coordinate all measured sketches and photographs. Trilateration, or measurement of a feature from two known places on the baseline, allowed archaeologists to accurately plot any artifact or construction detail on the site plan.

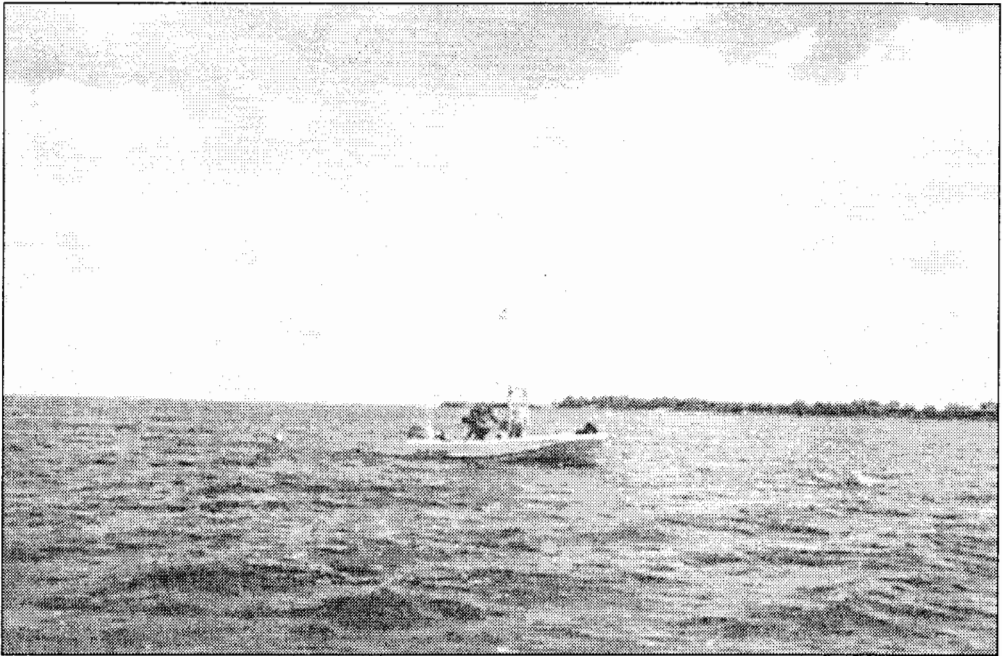
Plate 2. Research vessel *Orion* on site in Little Sturgeon Bay, Wisconsin. The buoys delineate the disarticulated wreck sections.

Diving operations were conducted from the research vessel *Orion* (Plate 2), a 22 foot Boston Whaler equipped with surface-to-diver communication gear, VHF radio, and a global positioning system (GPS). The GPS allows for extremely accurate navigation and plotting of points on the earth's surface utilizing orbiting satellite transponders and computer calculated trilateration. An inflatable boat was used to ferry shore parties and equipment. Divers were equipped with diver-to-diver, and diver-to-surface communication equipment. Underwater communication greatly enhanced the efficiency of the underwater survey while at the same time it improved diving safety by putting each diver in direct communication with other divers and the diving safety officer.

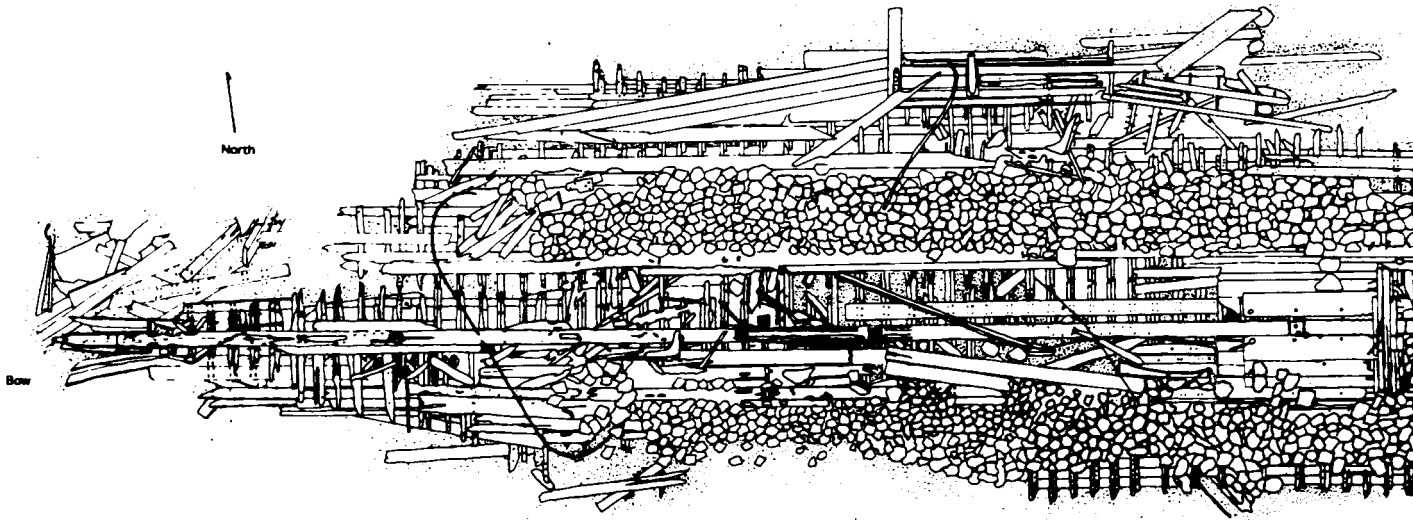
Clafin Point Wreck Site

Figure 3. The main section of the Clafin Point Wreck includes the lower hull, stern fantail and stern deadwood. Two linear

stern fantail and stern deadwood. Two linear piles of rock laying parallel to the keelson are the remains of the crib stone cargo.

Some of the map work, such as the main wreck site map (Figure 3) and the Claflin Point map (Figure 2), were initiated at the base camp near Sturgeon Bay. In this way gaps or errors in the data could be verified the next day. Most of the drawings were completed, however, at the archaeology laboratory at ECU from data collected during the three week field research segment.

The wooden hull of the Claflin Point vessel was carefully documented archaeologically (Figure 3). All nearby wreckage was also meticulously plotted and sketched.

Details of the construction techniques employed on the Claflin Point vessel can be gleaned from the cross-section (Figure 9) and the main site plan (Figure 3). Longitudinal support for the ship was supplied by the keel/keelson structure down the centerline of the ship. The keelson is slightly larger than the keel at 13 inches sided and molded to the keel's 12 inches sided and 10 inches molded. The ship was double framed and butt-scarfed, with the frames lying on two foot centers. Floor spacing decreased to almost nil under the boiler beds for added support of the heavy machinery. The frames were uniform (mill cut), 8 to 10 inches molded and 4 to 5 inches sided. Outer hull plank-

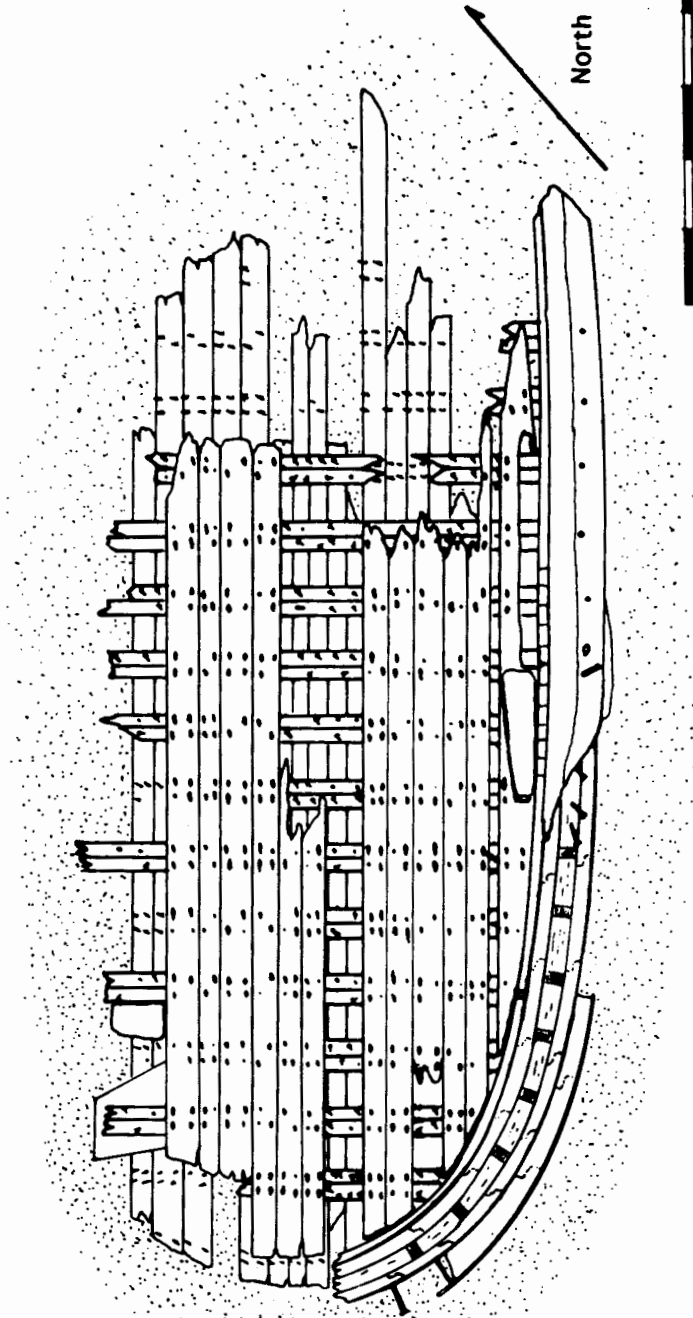
Clafin Point Starboard Fantail Section
Plan View 1995

Figure 4. A broken section of the stern fantail is south of the main wreck section.

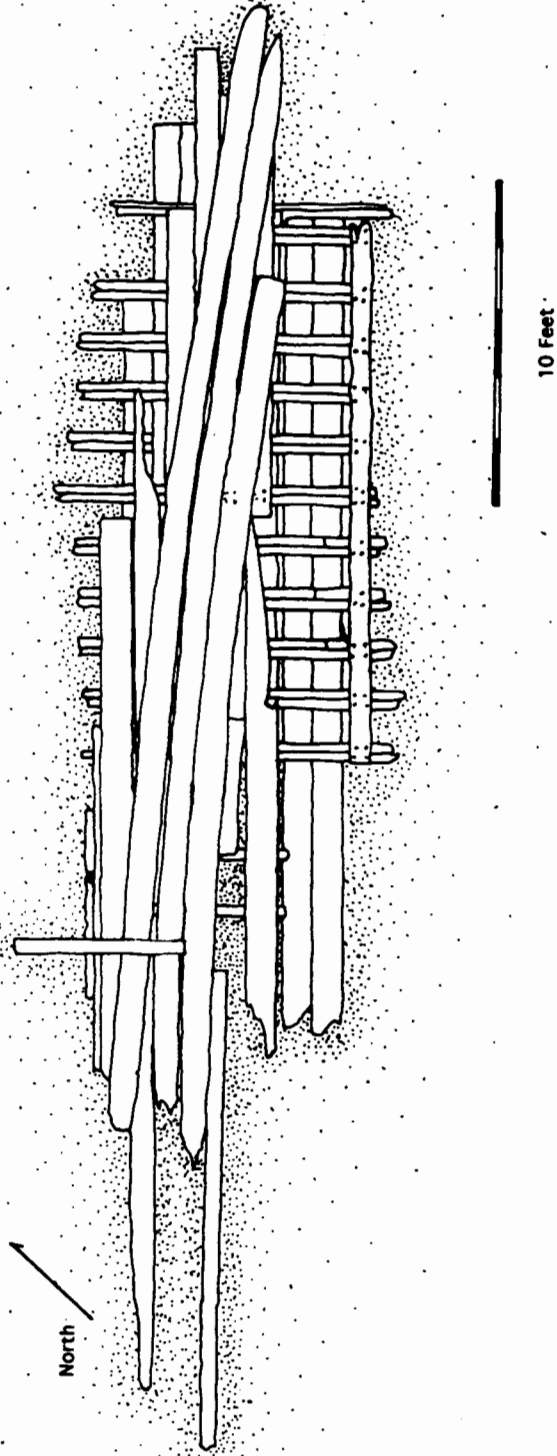
Clafin Point Port Side Hull Section
Plan View 1995

Figure 5. A section of the port side, found southwest of the main wreck section, includes a partially intact ceiling arch.

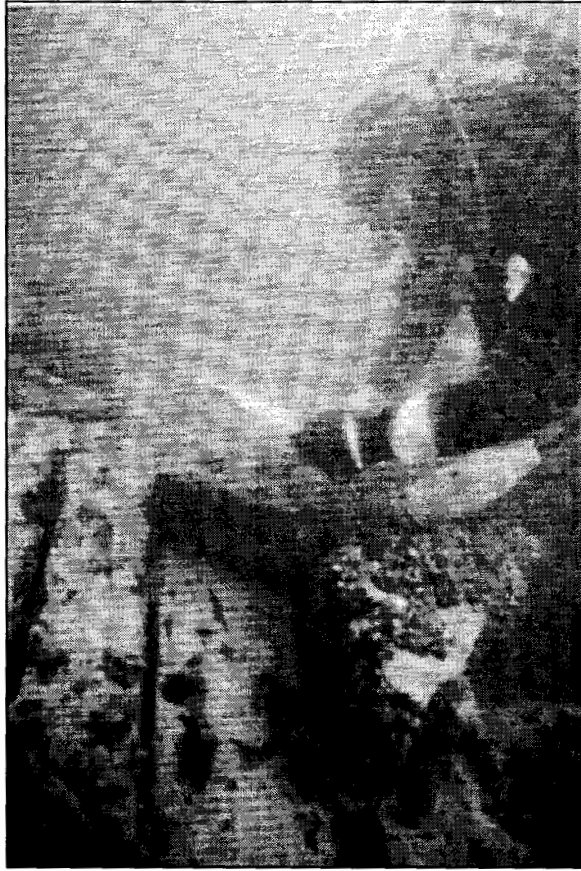
Plate 3.

Archaeological technician Wendy Coble produces a measured sketch of the engineering area in the main wreck section.

Yet, there is no machinery present to indicate that the Claflin Point vessel was being used as a steamer at the time of its sinking (Plate 3). In fact, since all orifices in the main hull section are plugged with wooden stoppers and secured, including the through-hull propeller shaft bearing, it seems likely that the machinery had been removed from this ship prior to its sinking. This is consistent with the hull being used as a barge. As the hold of the ship still contains a large quantity of quarried dolomitic limestone it is logical to assume it was being used as a rock transport barge at the time of its sinking. Archaeological evidence, however, decisively demonstrates that this was not its original purpose.

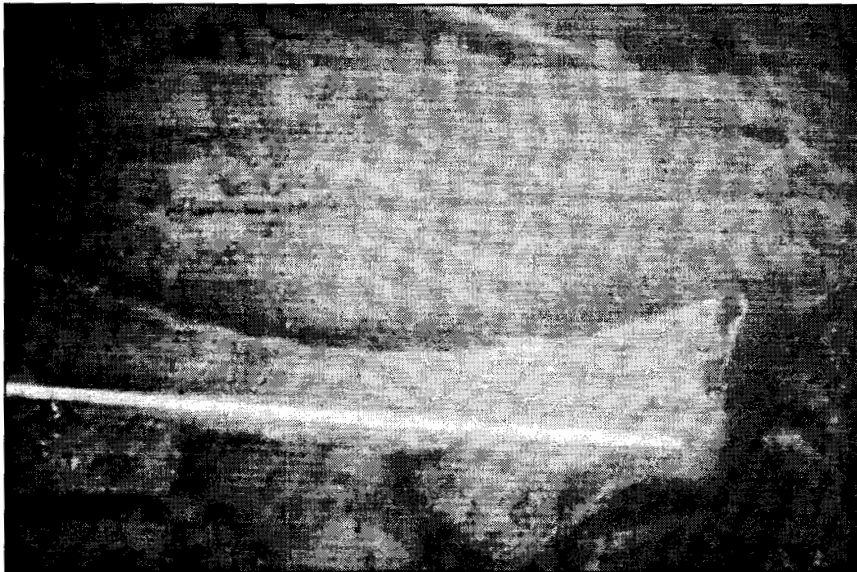
Plate 4.

A boiler saddle represents one of the few remaining diagnostic artifacts left in the engineering section.

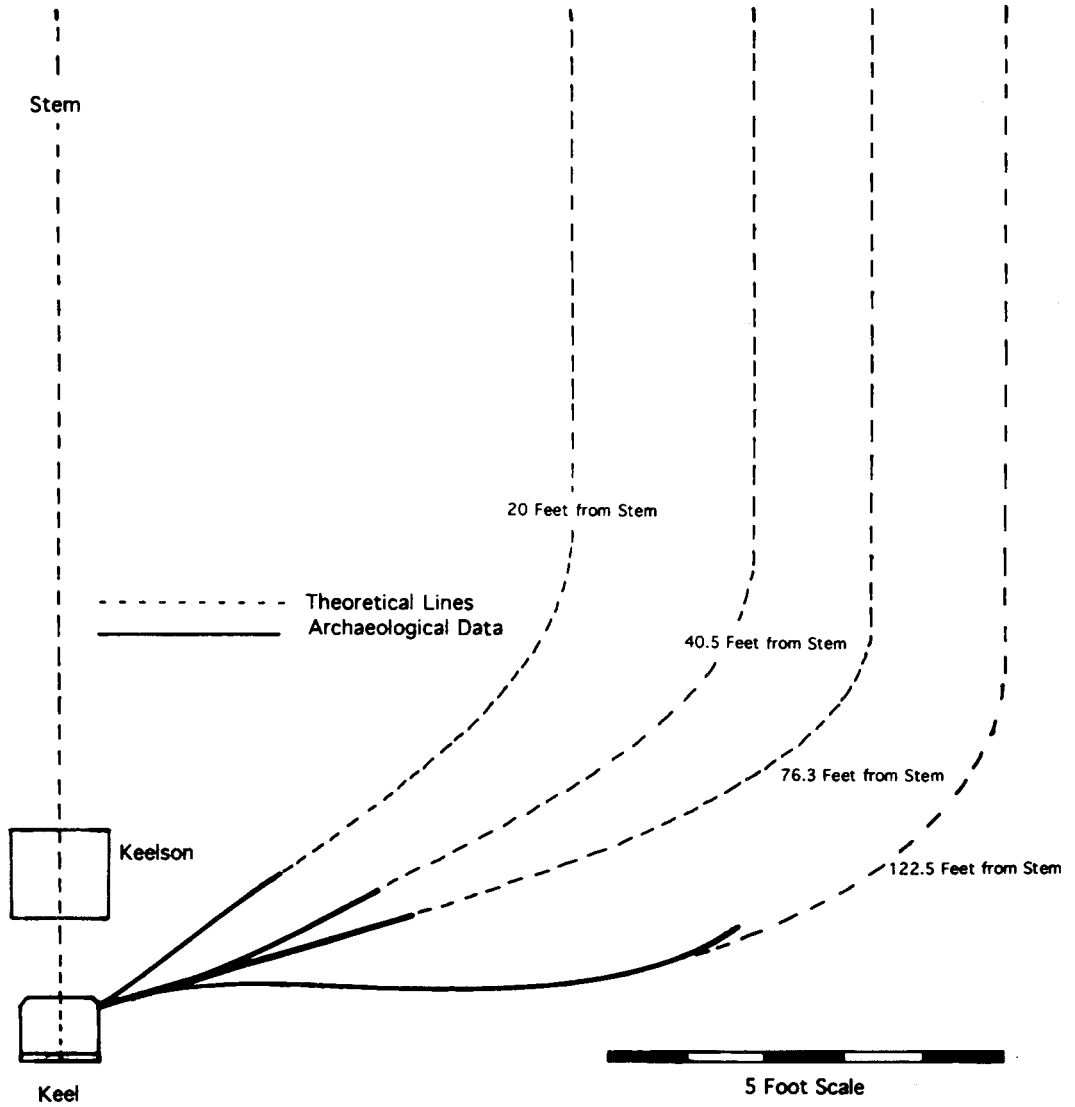
Clafin Point Vessel Lines

Figure 6. Reconstructed vessel lines from the Clafin Point Shipwreck based on archaeological data and theoretical projections.

Construction details paint the picture of a once fast, purpose-built steamship. Deadrise profiles (Figure 6) taken at the few areas inside the ship not filled with rock, demonstrate the graceful sharp lines of a vessel designed for speed and economy. These are not the boxy lines of a typical Great Lakes steam barge or bulk freight carrier. The profiles, combined with length and beam measurements recorded off the main wreck section, allow for a theoretical projection of hull shape (Figure 7) with dimensions. The plumb bow, wall sides, and fantail were typical of late-19th century Great Lakes steamships.

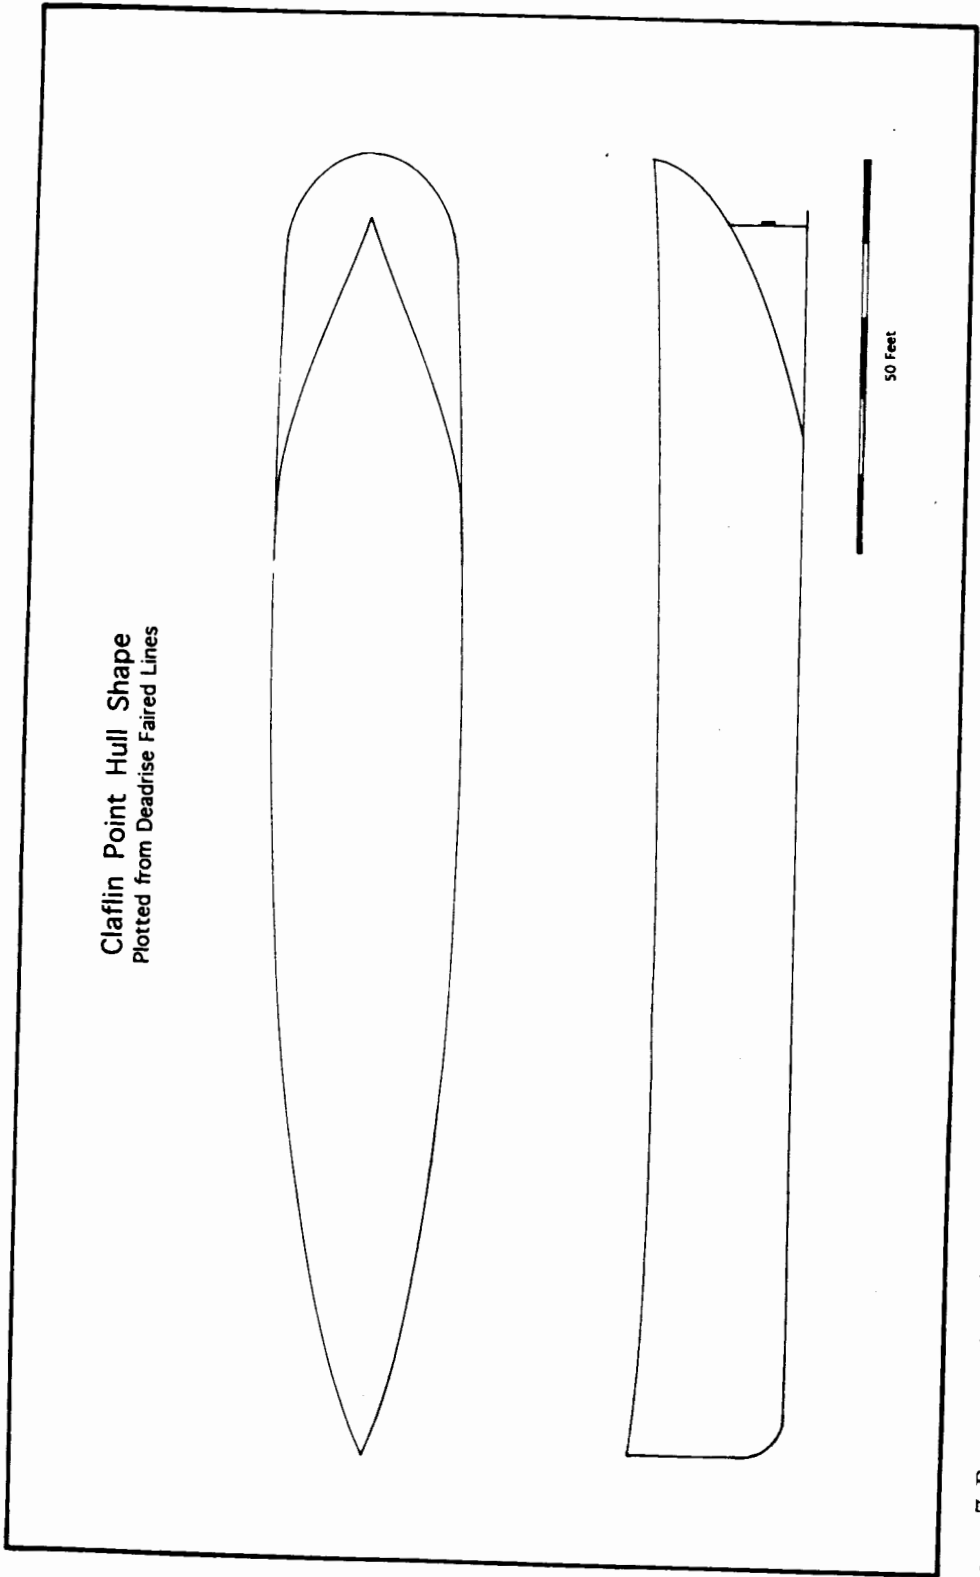
Figure 7. Reconstruction of the Claflin Point Shipwreck's hull shape.

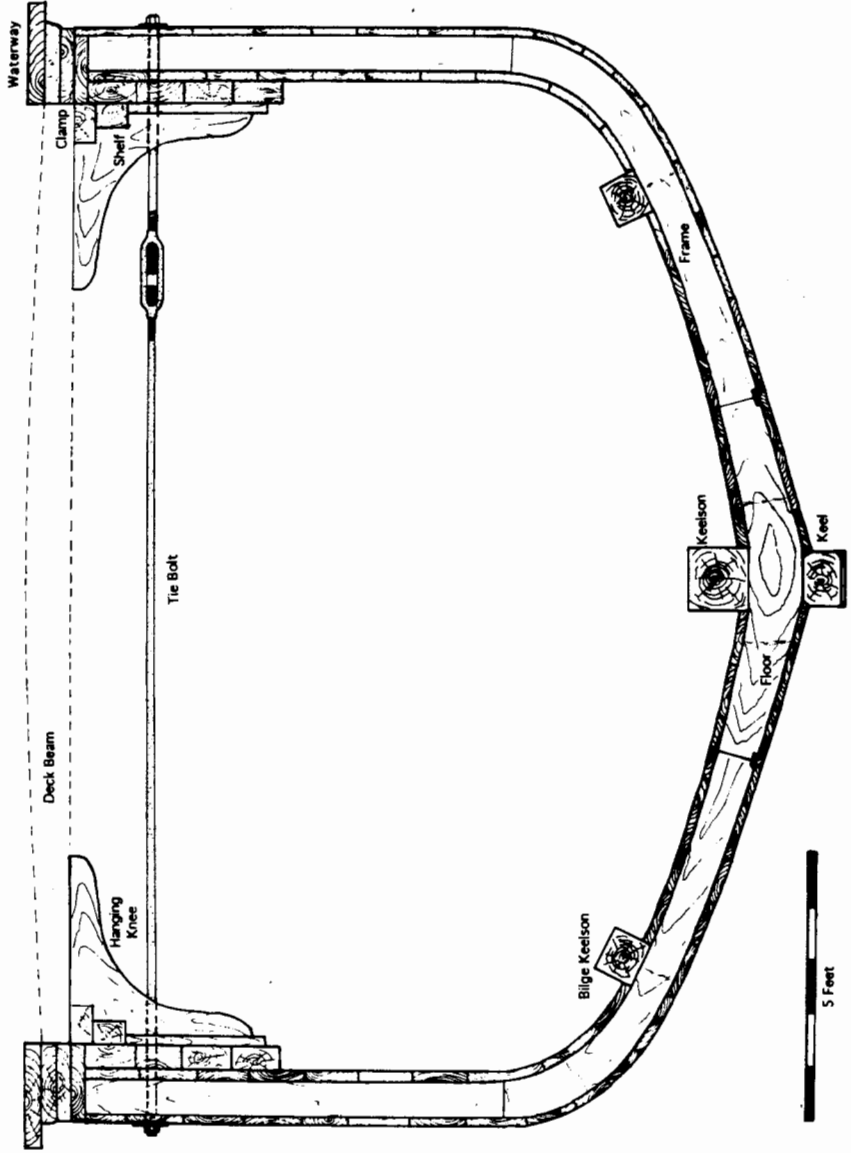
Clafin Point Vessel Cross Section

Figure 9. A reconstructed cross-section of the hull seventy feet aft of the bow.

A detailed cross-sectional sketch (Figure 9) was also created by recording components of the flattened bottom and sides of the ship and fitting them to the cross-sectional shape obtained from the faired lines projection (Figure 6). Faired lines were archaeologically calculated by stretching a level line perpendicular to the keelson and measuring down systematically with a plumb bob to the ceiling. In this way the curvature of the bottom of the ship, or deadrise, could be plotted. This procedure was made difficult by the large amount of crib stone resting on the wreck site. Photographs and a video pass, or "fly over," oriented to the baseline completed the predisturbance survey.

ing was slightly thinner than the ceiling planking at 1.5 or 1.75 inches for the hull, to 2 or 2.25 inches for the ceiling. The hold was supported longitudinally by port and starboard bilge keelsons, 10 inches square. Preliminary observations show the ship to be of oak.

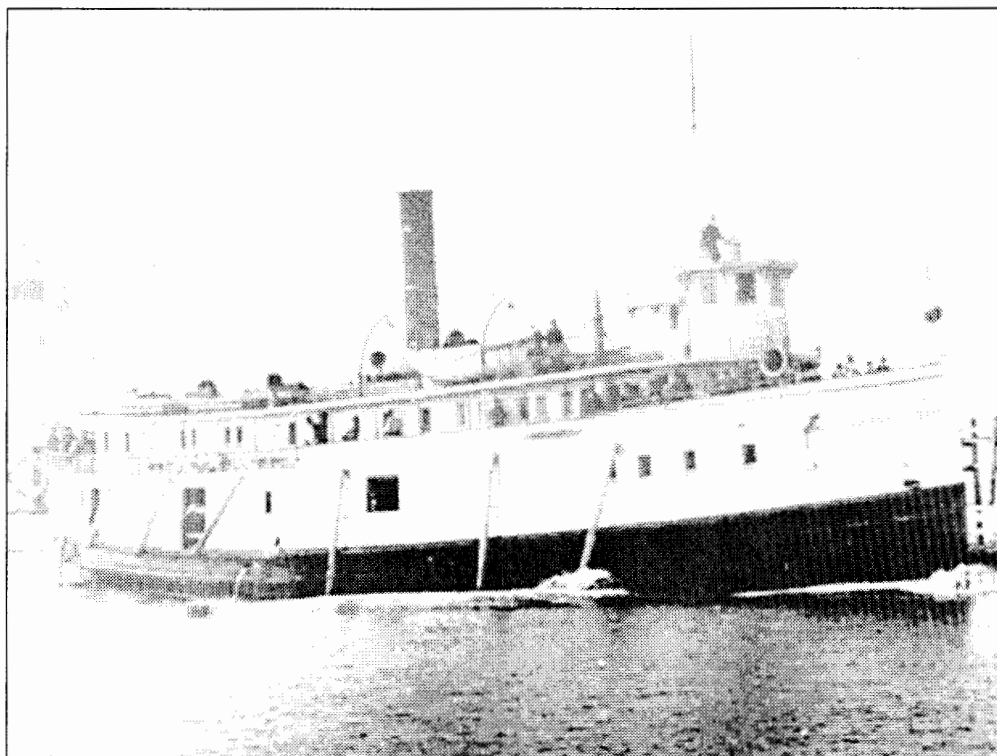
Plate 6. A typical ship-to-barge conversion as seen in this stern view of the *Alaska*. Note the through-hull shaft bung (Van der Linden 1979:11).
